## Orongo Ceremonial Center: Past, Present and Future

Robert R. Koll  
Ajijic, Mexico

Since early in the 20th century and until the present, reports on the condition of the houses of Easter Island's ceremonial center, Orongo, have varied from "ruins" to Mulloy's "fine restoration." This paper brings together comments by earlier researchers and reports on the problems facing this site today.

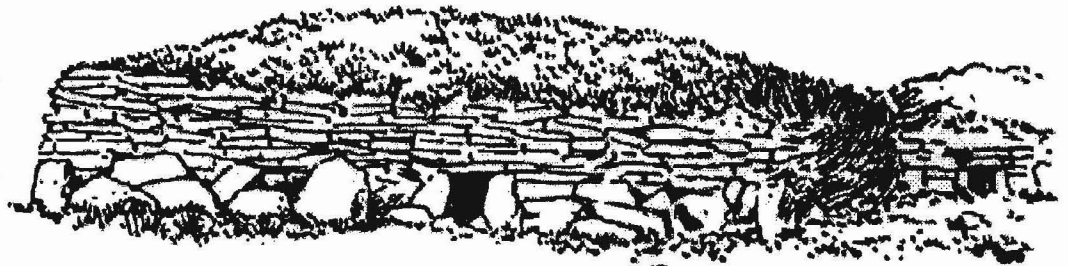
Figure 1: General view of the houses as seen by Thomson in 1888.

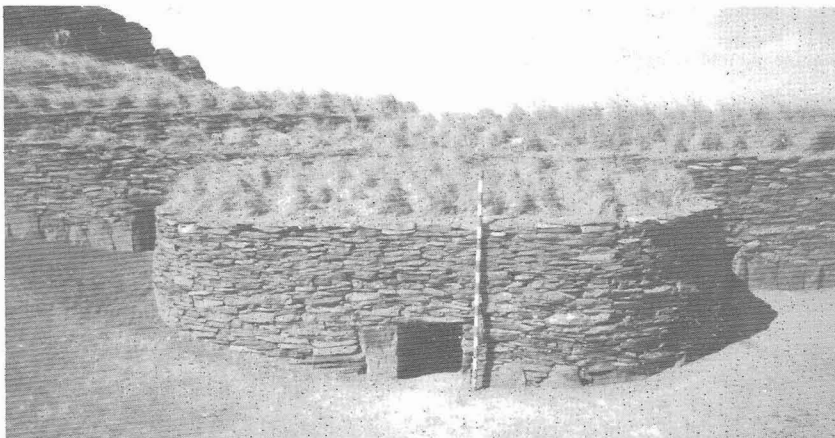
Figure 2. Photograph showing one of the houses at Orongo at the time of excavation by Mulloy. (Photo courtesy Emily Ross Mulloy)

The exterior wall heights listed below are estimated from stadia rods shown leaning against walls in photographs. (Fig. 2) The walls range in height from 1.4 m to 2.6 m.

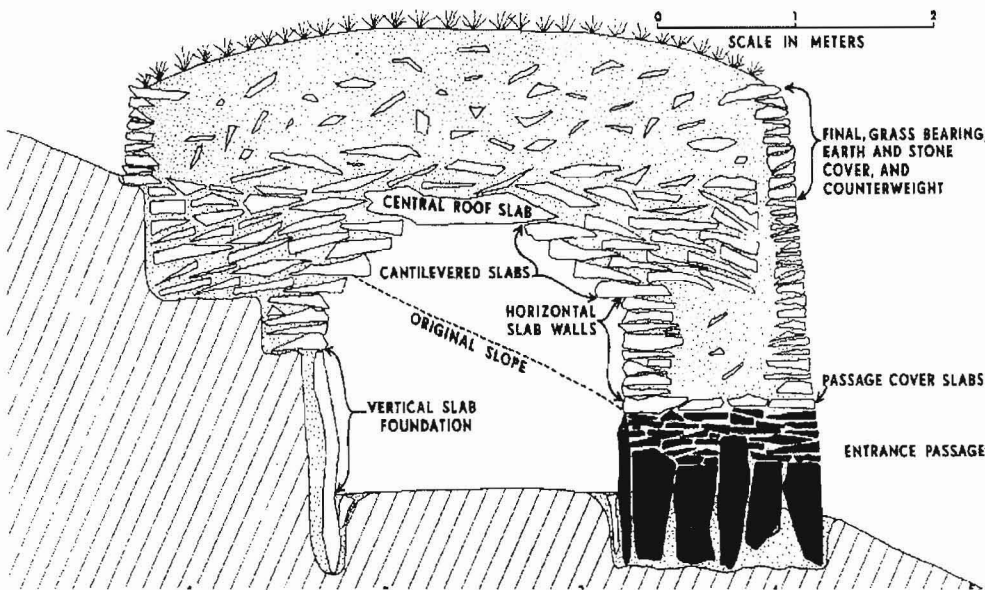
Figure 3: Construction of a typical house. (from Mulloy, Bulletin 4, Easter Island Committee, International Fund for Monuments, 1974)

According to Mulloy, to restore the Orongo houses it was necessary to rebuild not only the walls that had slumped due to outward tilting of the partially embedded vertical foundation stones but also those walls where the foundation stones had begun to tilt. If not vertical, the great weight of the stone wall and earth forced them outward, thus causing the walls to collapse. In turn, any slumping of an interior wall caused the ceiling to collapse. The major cause of the collapse of the walls and roofs of the houses was the outward tilting of the vertical foundation stone slabs. (Fig. 3)

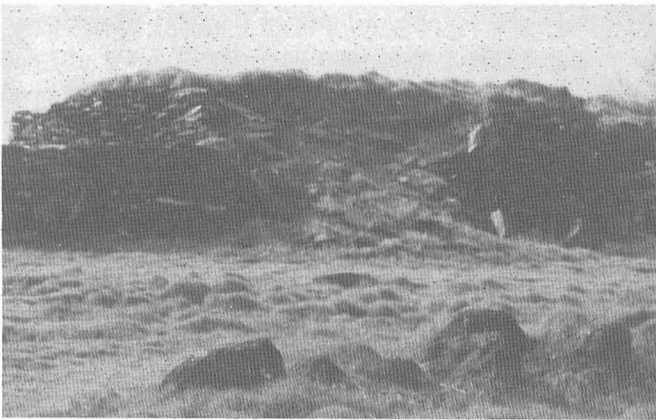
Figure 4: A recent photograph of a collapsed house at Orongo.  
(Photo: Georgia Lee).

At the present time, the condition of Orongo's houses and petroglyphs ranges from fair to destroyed. In 1993, nine or ten houses were reported as having collapsed, some due to heavy rains (Anon 1994). (Fig. 4)

Although hard to prove, it is likely that some collapsed due to excessive weight as a direct result of the Hollywood movie made on the island in that year. During filming, some 275 people were at Orongo for nearly two months. Equipment, supplies, and general pressure on the houses and petroglyphs surely had an impact. Three huge plastic *moai* (facing out to sea) were placed above the houses and an addition was constructed on the cliff. People wearing shoes were observed walking on the roofs of the houses and on the petroglyphs. Allen (1993) reports: "Using conservative numbers, if one estimates that 200 people made the trip to and from the set twice daily, for 25 days, that is the equivalent of 20,000 people--perhaps a greater number than have visited the site over the last century. Again, this figure

Whether or not the activities and traffic due to the making of the movie caused additional damage to an already fragile site is a moot point. Damage has been done, and it is continuing. The houses are unstable and must be repaired and reinforced before they become lumps of jumbled stone and dirt. Some conservation methods must be applied to the petroglyphs if they are to survive. The petroglyphs are on basalt boulders and yet foot traffic has caused the designs to wear down to the point where some of the motifs are no longer clear. Although rock is considered sturdy and durable, constant friction will wear it down. Despite this, there are no safeguards in place to prevent further damage.
